CONDITION SURVEY OF POROUS FRICTION SURFACE COURSE

James E. Shoenberger

U. S. Army Engineer Waterways Experiment Station
Geotechnical Laboratory
P. O. Box 631, Vicksburg, Miss. 39180

APRIL 1981
FINAL REPORT

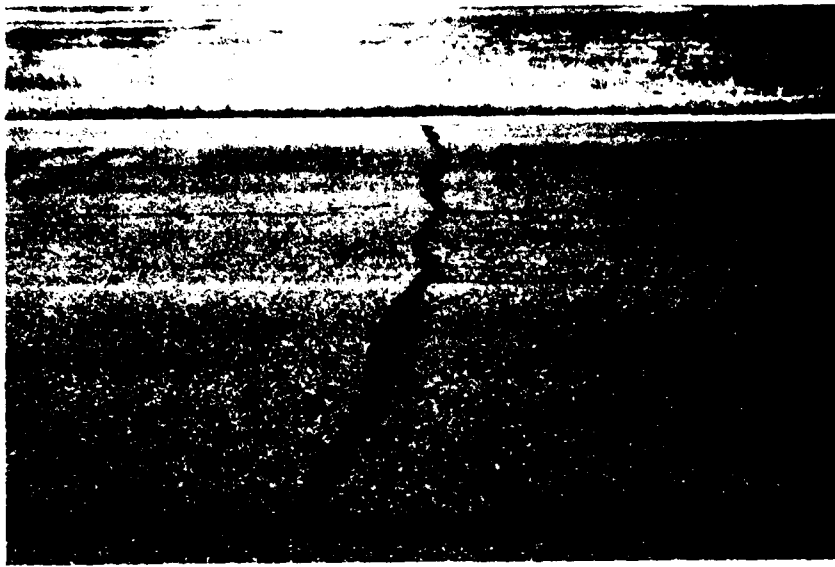
Figure 1. Sealed reflective cracks
(runway 16-34, Great Falls)
